South Penquite, Blisland, Cornwall

Archaeological Assessment

**South Penquite, Blisland,
Cornwall
Archaeological Assessment**

Report No: 2005R021

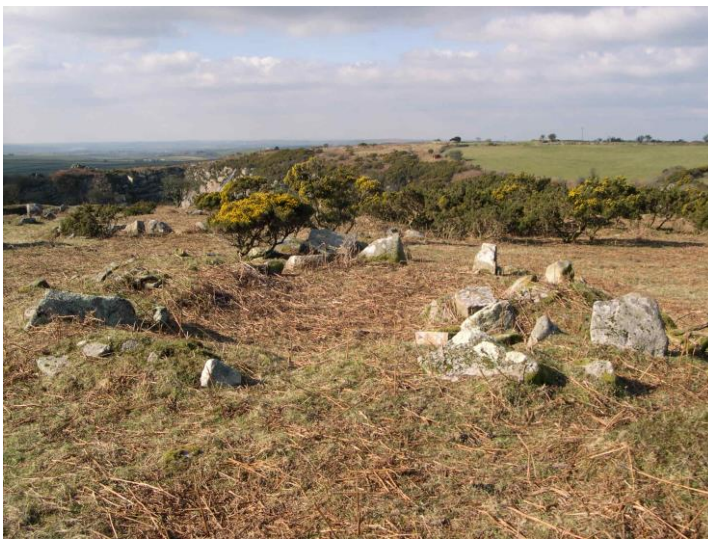
Plate 1; Hut circle 42
looking north west.
Note internal ring of
granite stones on edge.
Photograph by author

Recommendations *This nationally important hut circle should be kept as visible within the landscape as possible. It is of great educational value in that it is clearly a prehistoric hut circle and easily interpretable as such. We would encourage regular monitoring for weathering by livestock and in the event of such the site could be temporarily fenced off by an electric fence to allow for stabilisation. It is probable that buried archaeology still survives within the hut circle and porch and therefore the lighting of fires and the digging of holes within the feature should be discouraged.*
